Title of Report: Cultural Resources Monitoring and Inadvertent Discovery Plan for  
8801 East Marginal Way South, Tukwila, Washington

**8801 East Marginal Way South Remediation Project  
Cultural Resources Monitoring  
and Inadvertent Discovery Plan  
Tukwila, Washington**

DAHP Project #2019-03-01609.

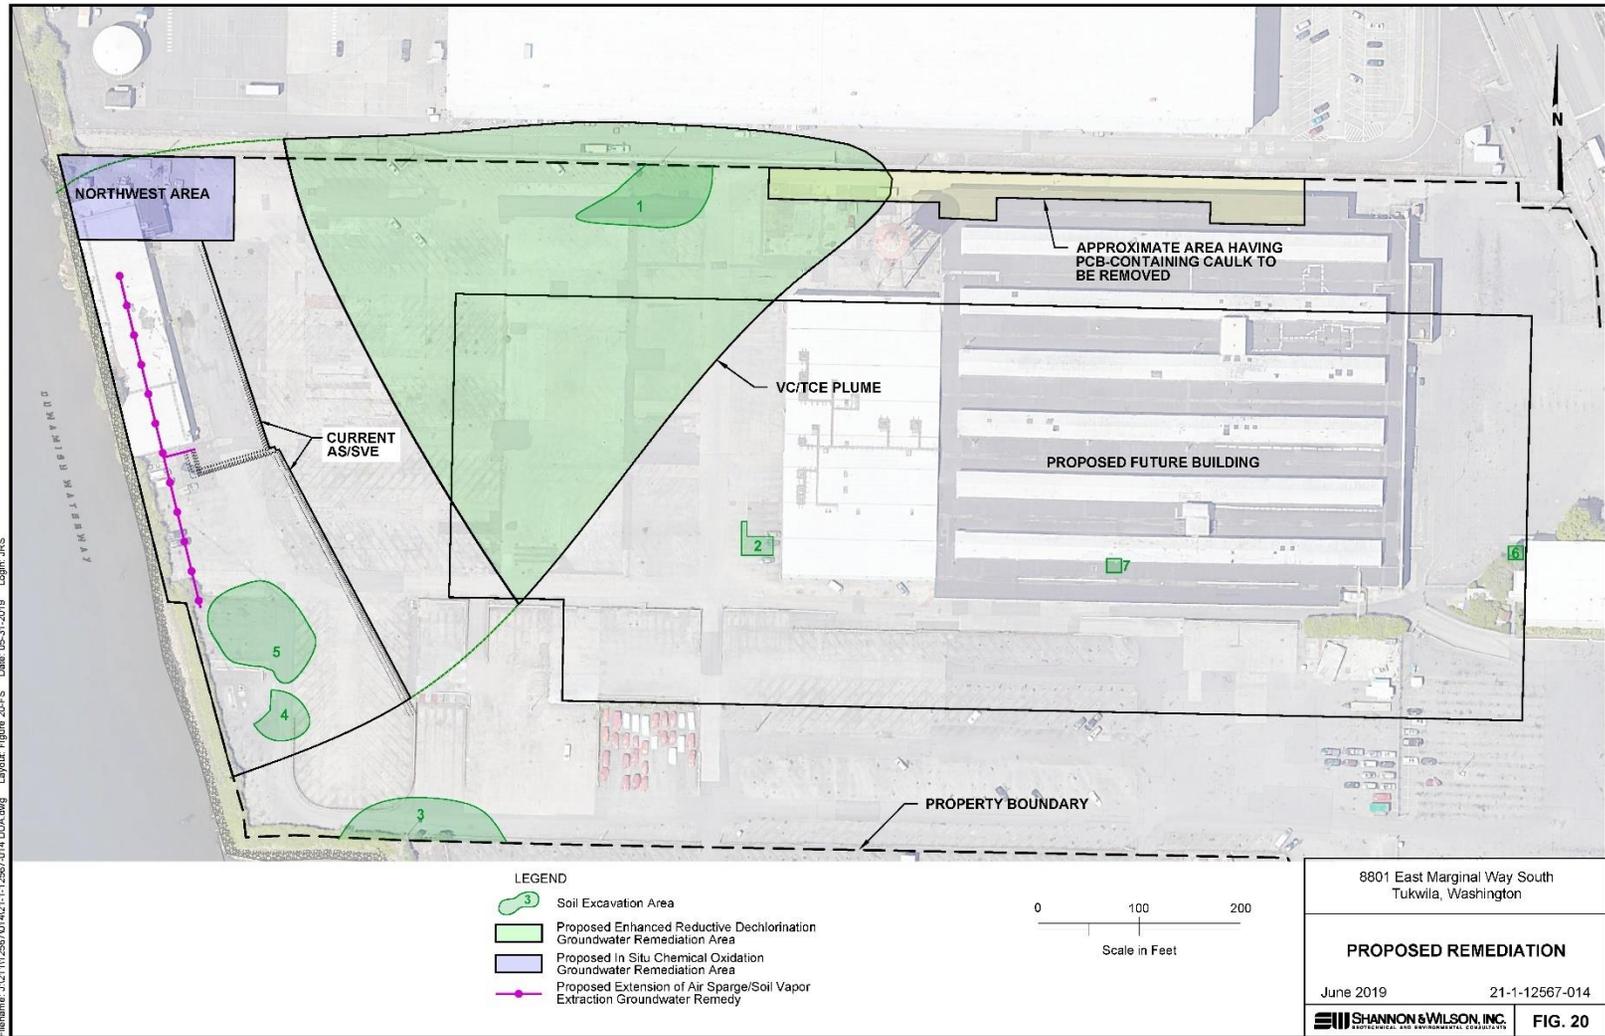
Figure 3. Draft project plan map from Shannon & Wilson.

Stell was contracted by Shannon & Wilson, Inc. to create a cultural resources monitoring and inadvertent discovery plan for the 8801 East Marginal Way South Remediation Project, Tukwila, Washington project (Project) (Figure 1) (see Appendix A for Inadvertent Discovery Plan). Contaminated soil has been identified in a few locations within the Project area. Shannon & Wilson, Inc. is proposing to undertake a remediation of contaminated soil and water throughout the project area. Seven discrete excavations are proposed to remove contaminated soil (as shown in Figure 3).

The Project area is located on the right (eastern) bank of the Lower Duwamish Waterway (LDW), approximately four miles upstream from the mouth of the Duwamish River, in Section 33 of Township 24 North, Range 4 East, Willamette Meridian. The upland portion of the Project area occupies 24.30 acres at 8801 East Marginal Way South (King County Parcel No. 5422600060), in the City of Tukwila, Washington (see Figure 1 through Figure 3).

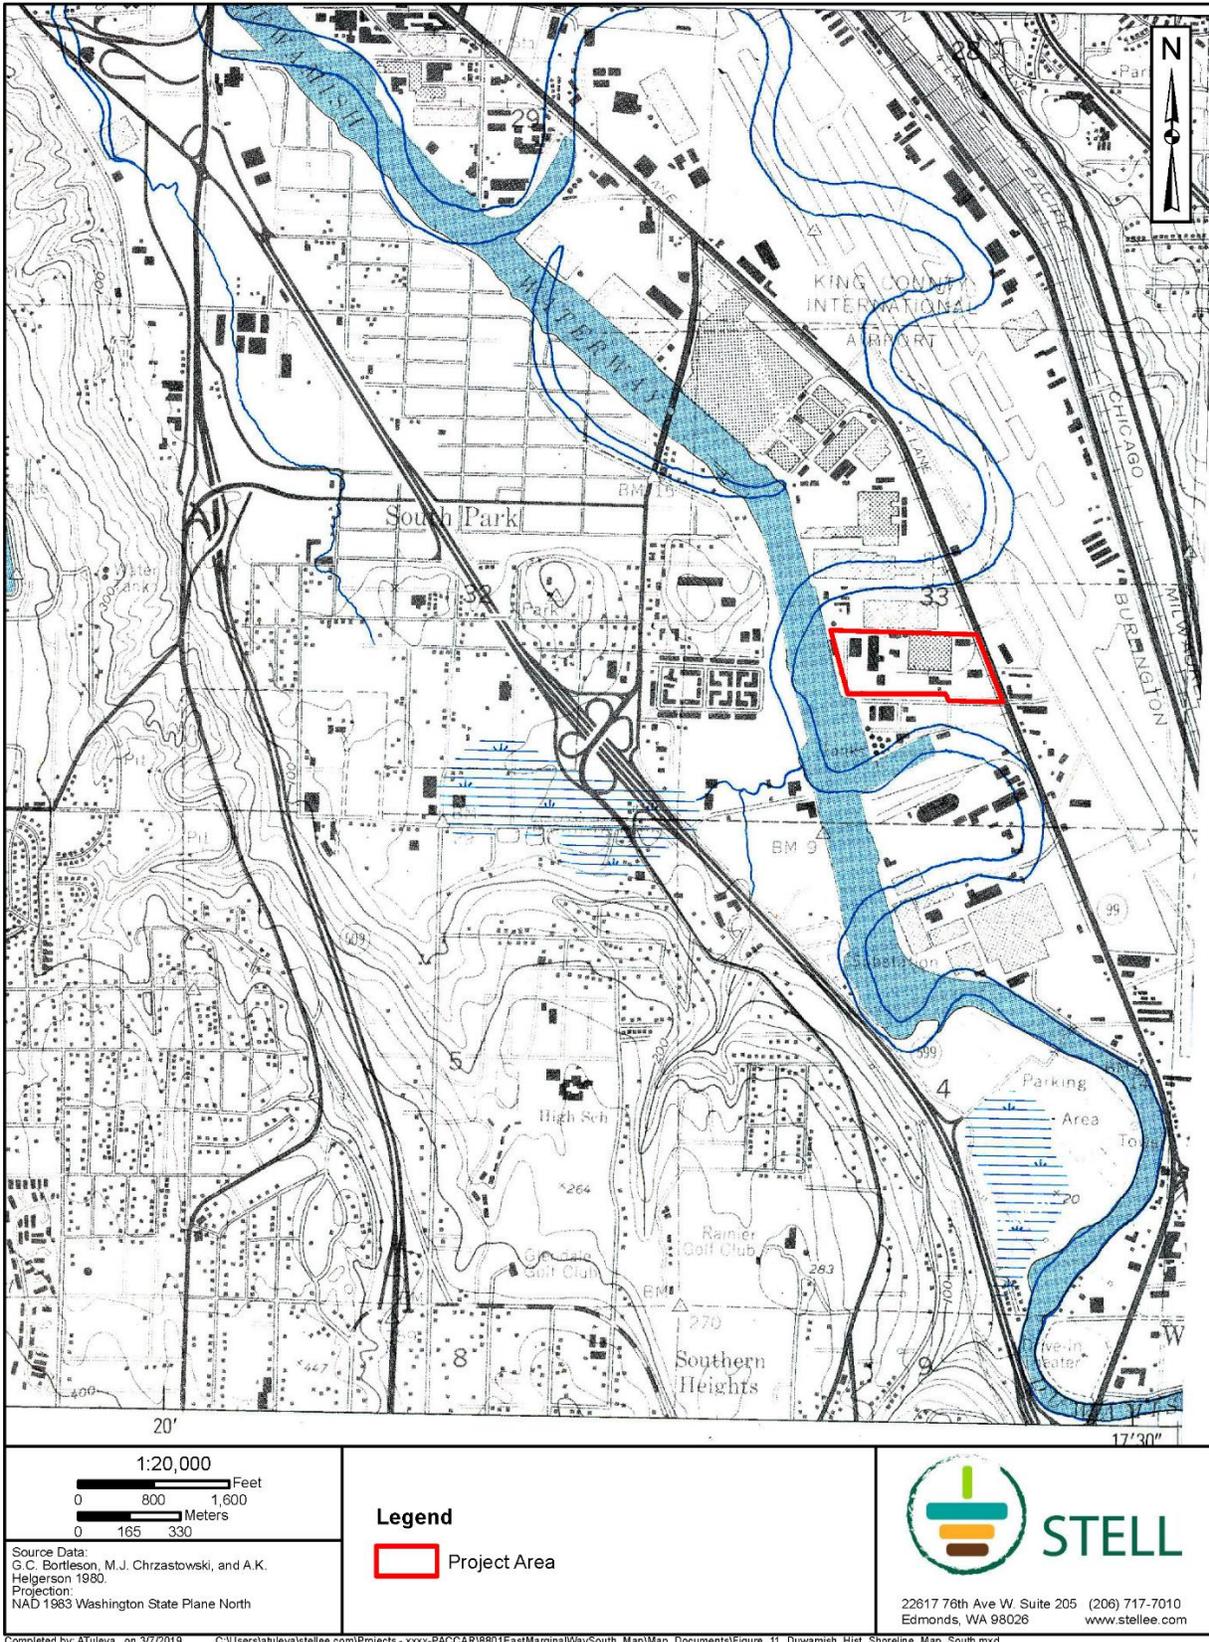
Figure 4. Duwamish River historical channel map.

Stell's cultural resources review (Steinkraus and McWilliams 2018) found that previously recorded archaeological sites in the area consist of precontact isolates and several shell middens, as well as historic features and refuse concentrations. In terms of archaeological expectations, it is possible that these types of materials may also be located within the project area. This area is along the meander belt of the Lower Duwamish River which was a major travel corridor until the Puget Sound region was logged and roads were constructed in the late 1800s and early 1900s. The placement of the Project area on a notable bend in the river (prior to channelization efforts in the early 1900s) increases the likelihood that humans stopped in this area and therefore increases the odds that cultural materials are present (Figure 4).

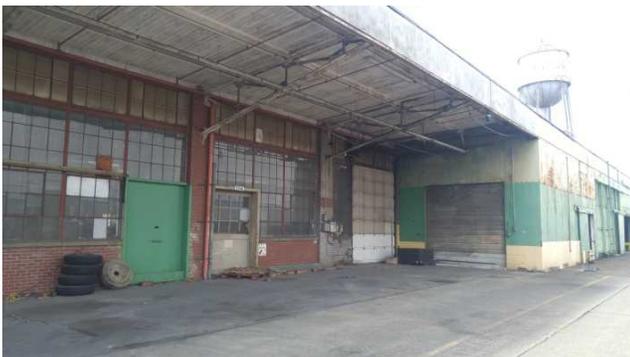
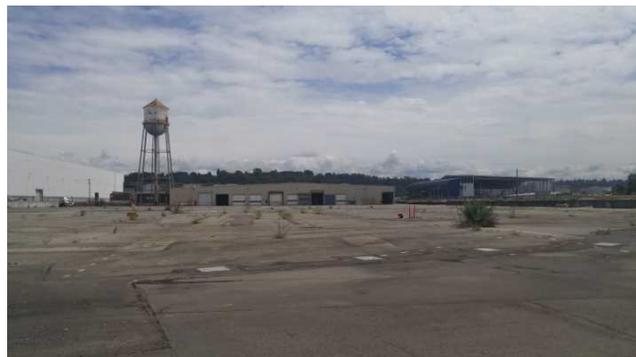
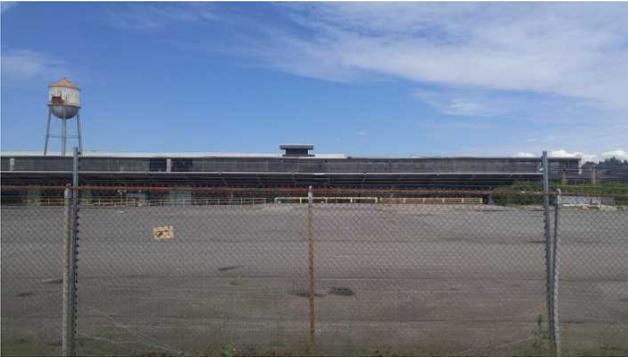
Structure 1 North Facade.jpg

Structure 1 West Facade.jpg

Structure 1 South Facade.jpg

Large, fixed, steel-framed, multi-pane windows with floating vents are located on both the north and south façades of the monitors. Exterior walls of the building originally consisted of brick masonry and large, fixed, steel-framed, multi-pane windows with floating vents on the north, south, and east façades. Although many of the original windows have been retained on the north and south facades, windows and doors on the east façade, except for at the southeast corner, were replaced after 1965. Since the construction of a warehouse addition resulted in the removal the west façade of the building between 1969 and 1980, its original configuration is unknown.

When the building was initially constructed, the property featured two railroad spurs that ran along the north and south façades of the structure. The original loading doors, which were likely primarily wood and folding-style, featured bands of steel-framed, fixed, multi-pane clerestory windows above. These loading doors were interspersed along the north and south façades in order to load and unload materials from the train cars. Although all doors have been replaced, except those at the western end of the north façade and some on the south façade, most original openings have been retained. Metal-framed awnings with a wood soffit were included in the original design of the building on the north and south façades in order to shelter the railroad tracks during shipping and receiving.

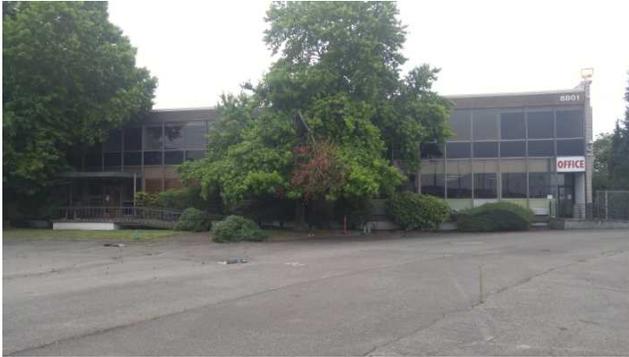
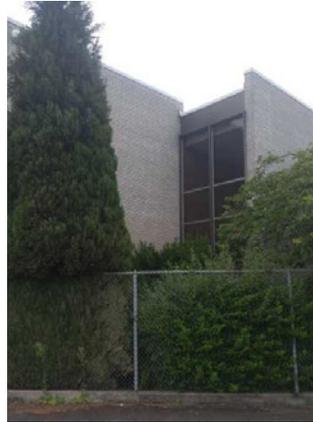
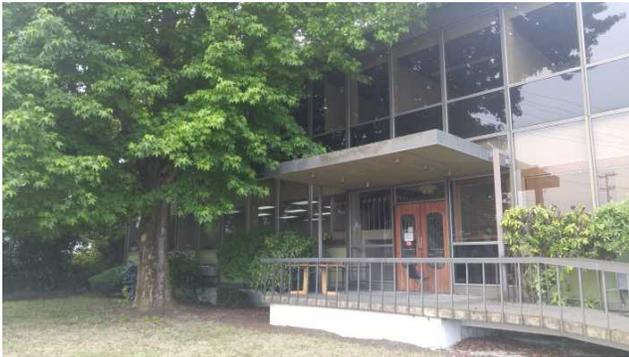
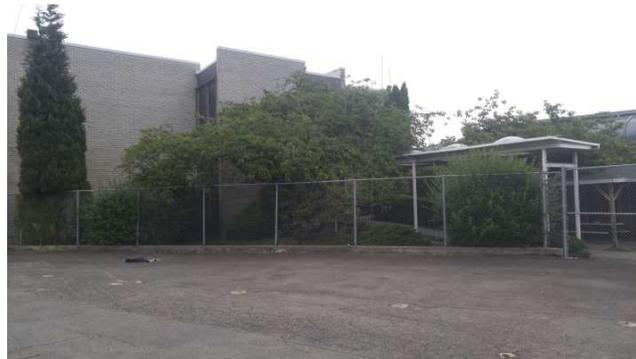
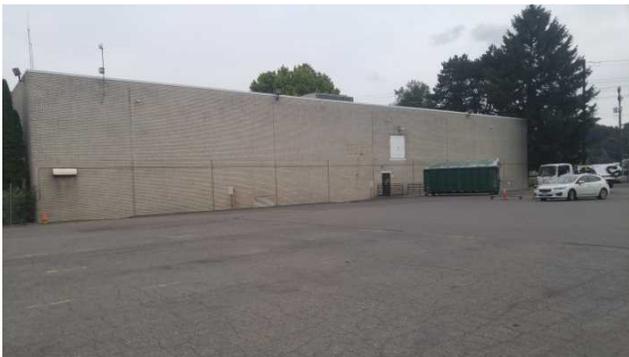
North facade of Structure 2.jpg

North facade of the western entryway projection on Structure 2.jpg

View of central main entrance on the primary (north) facade.jpg

West facade of Structure 2.jpg

South facade of the Kenworth Office Building.jpg

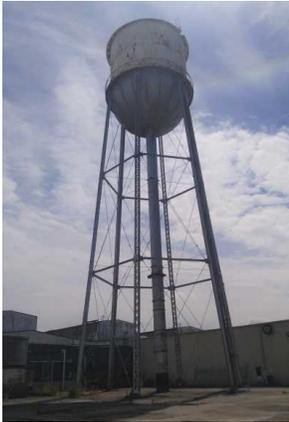
Structure 3.jpg

**Physical description:** The Fisher Body Corporation Woodworking Plant Water Storage Tank was designed as an elevated, spheroid-bottomed, riveted steel plate, water storage tank with a conical roof that is supported by six Z-laced girder steel legs. Built between 1928 and 1929, the water tower served to provide water pressure to the FBC manufacturing facility. No manufacturer's plaque or builder information could be found for the water storage tank.

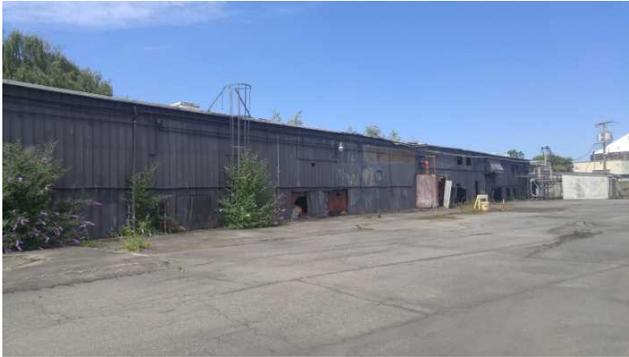
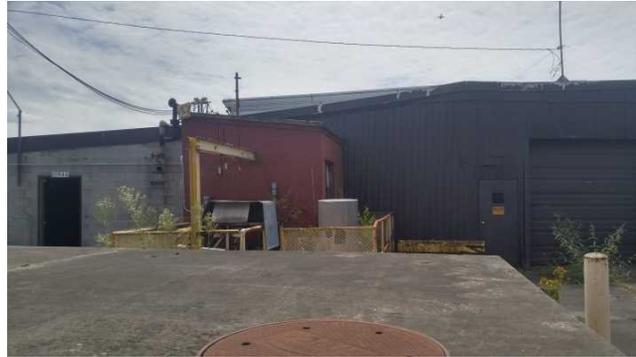
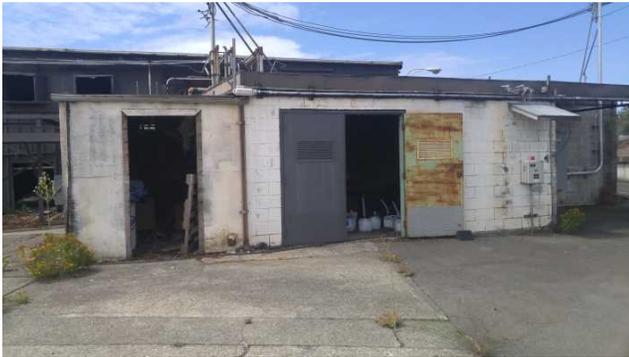
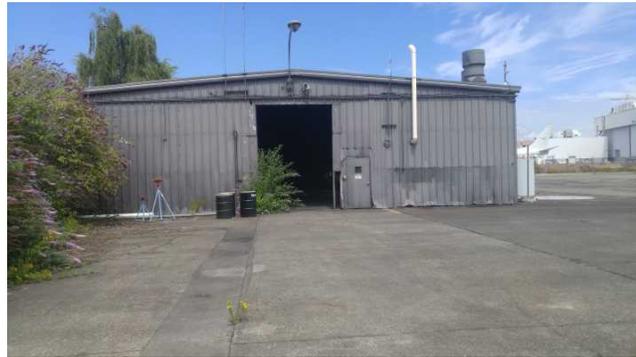
Groundwater Treatment Facility East Facade.jpg

Groundwater Treatment Facility North Facade.jpg

Groundwater Treatment Facility Additions East Facade.jpg

Groundwater Treatment Facility South Facade.jpg

No windows are located on the east façade and only one doorway with a hollow metal door is present near the northern end. Additional openings have been cut into the metal along the east façade of the building, but no window or door framing is present in the openings. Several sections of the east façade have also begun to rust off or have already fallen away.
